Smoke and Dye Testing Summary

High Level Sewershed

Test ID	Test Type	Date Inspected	Company / Super.	Blower MH	Ground Condition	Notification Made?	Total Length
S1028-035	Smoke	8/18/2008	ADS/TM	S11WW_013MH	Dry	Yes	2,132.22

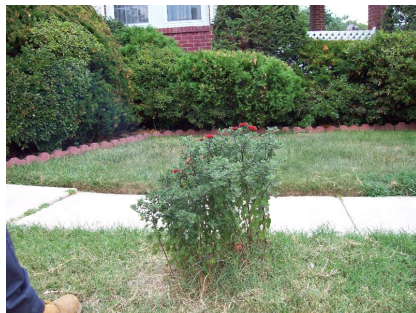
Picture \S1028-035-OB01-P01.jpg

Source Cleanout

Location Yard - front

Comments Smoke from cleanout in front yard. 3613 Dennlyn Rd.

Comments Front of house, 3613 Dennlyn Rd.

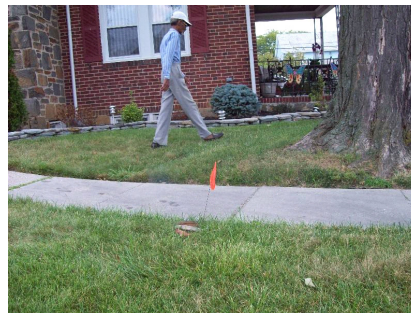
Picture \S1028-035-OB02-P01.jpg

Source Cleanout

Location Yard - front

Comments Smoke from cleanout in front yard. 3611 Dennlyn Rd.

Comments Front of house, 3611 Dennlyn Rd.

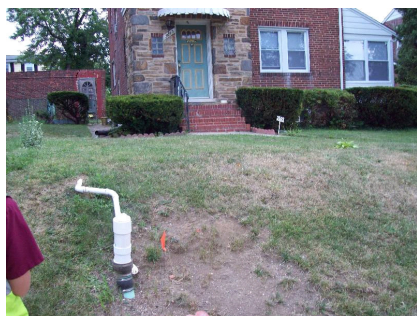
Picture \S1028-035-OB03-P01.jpg

Source Cleanout

Location Yard - front

Comments Smoke from cleanout in front yard. 3603 Dennlyn Rd.

Comments Front of house, 3603 Dennlyn Rd.

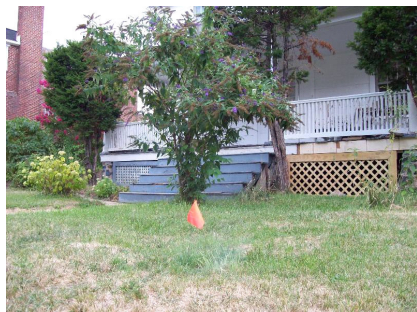
Picture \S1028-035-OB05-P01.jpg

Source Cleanout

Location Yard - front

Comments Smoke from cleanout in front yard. 3509 Dennlyn Rd.

Comments Front of house, 3509 Dennlyn Rd.

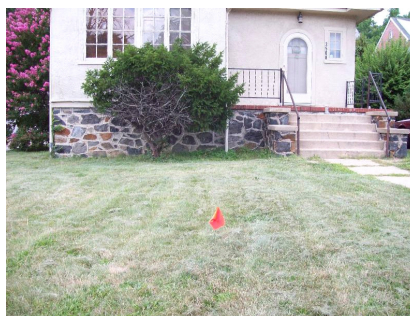
Picture \S1028-035-OB04-P01.jpg

Source Cleanout

Location Yard - front

Comments Smoke from cleanout in front yard. 3508 Dennlyn Rd.

Comments Front of house, 3508 Dennlyn Rd.

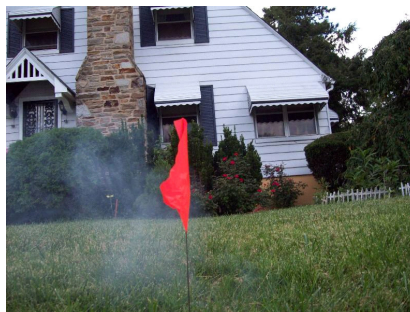
Picture \S1028-035-OB06-P01.jpg

Source Cleanout

Location Yard - front

Comments Smoke from cleanout in front yard. 3505 Dennlyn Rd.

Comments Front of house, 3505 Dennlyn Rd.

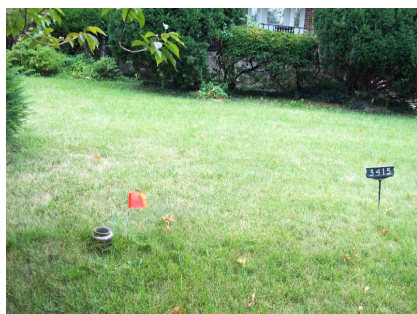
Picture \S1028-035-OB07-P01.jpg

Source Cleanout

Location Yard - front

Comments Smoke from cleanout in front yard. 3415 Dennlyn Rd.

Comments Front yard, 3415 Dennlyn Rd.

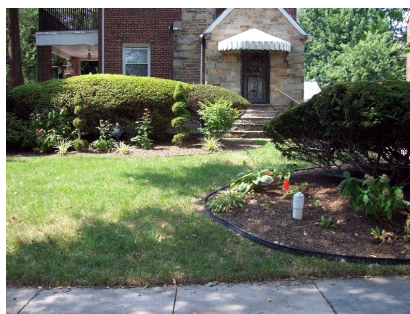
Picture \S1028-035-OB08-P01.jpg

Source Cleanout

Location Yard - front

Comments Smoke from cleanout in front yard. 3412 Dennlyn Rd.

Comments Front of house, 3412 Dennlyn Rd.

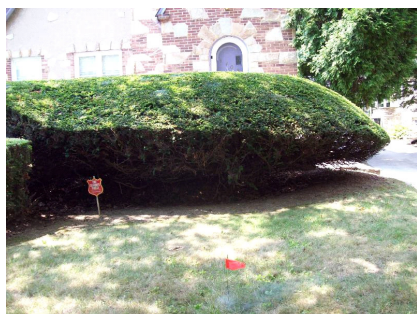
Picture \S1028-035-OB09-P01.jpg

Source Cleanout

Location Yard - front

Comments Smoke from cleanout in front yard. 3408 Dennlyn Rd.

Comments Front of house, 3408 Dennlyn Rd.
